**INDIAN LAKE STONE DAM**

**HAMILTON COUNTY  
NEW YORK**

5 **PHASE I INSPECTION REPORT**

1 **NATIONAL DAM SAFETY PROGRAM**

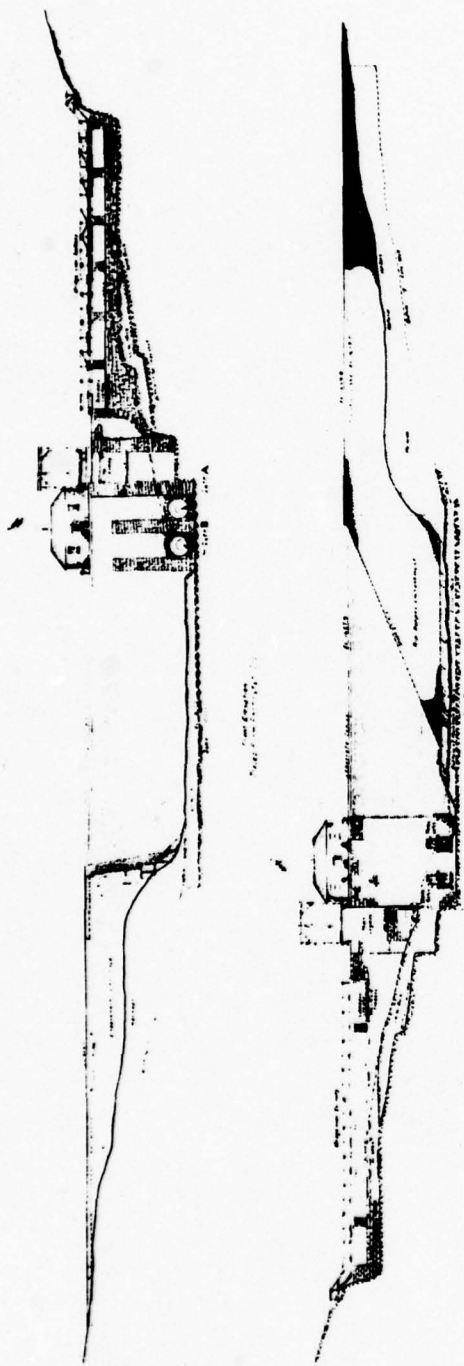
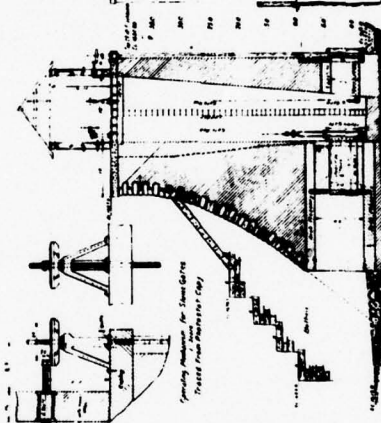
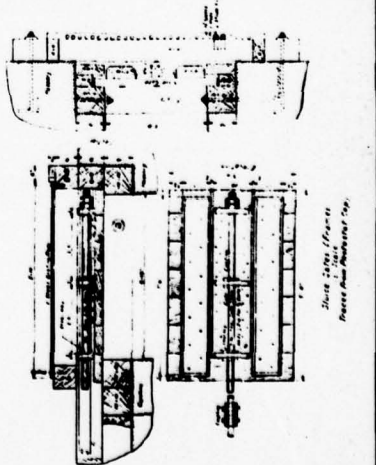
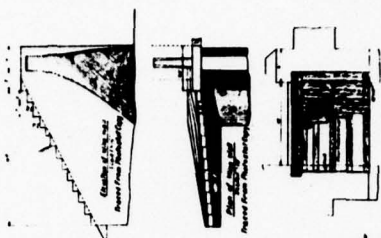
## FIGURE 2

The dam and spillway system visually conforms to the plans as shown in Figure 2. The south end of the dam consists of an earthfill section with rubble masonry core wall. This earthfill section is at an elevation two feet above the remainder of the dam. The earthfill on the downstream slope is covered with trees that have been long established on the slope. The upstream slope of the earthfill section is riprapped to the bottom of the slope in the reservoir. There is some minor displacement of riprap near the point where the earthfill section joins the masonry dam. Some seepage was noted along the downstream toe of the earthfill section near the south abutment and near the place where it abuts the masonry section. The seepage would not be described as severe and was observed at a time after a substantial rainfall.

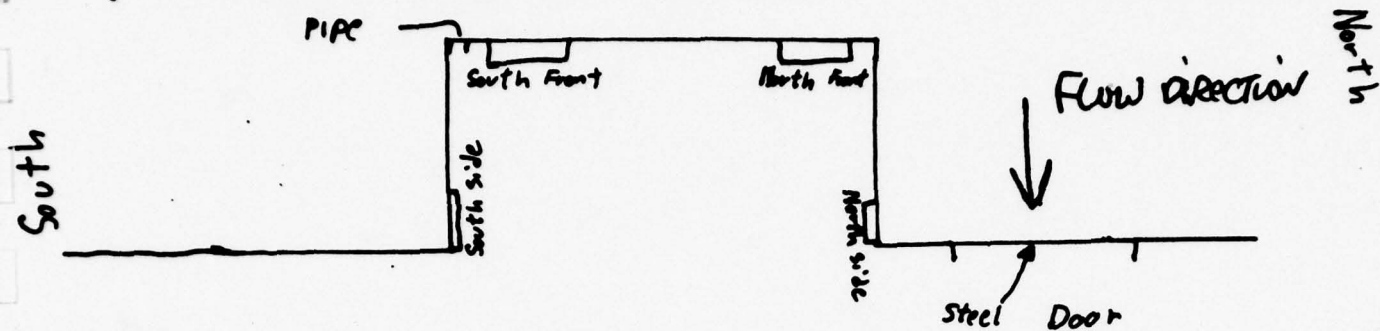
Fig. 1: Gate Location UPSTREAM

Three of the four upstream gates (North side, North front, South side) were obstructed by lake debris (see figure 1). Debris consisted mostly of broken tree limbs, logs, leaves, etc. The limbs and logs intertwined to form a net-like structure in such a fashion that the three blocked gates were not visible. (See figure 2)

Adjacent to the south front gate is a pipe opening approximately 5 inches in diameter. It is located between the south front gate and the south front corner approximately 2 inches from the bottom. It is free of any obstructions (see figure 1).

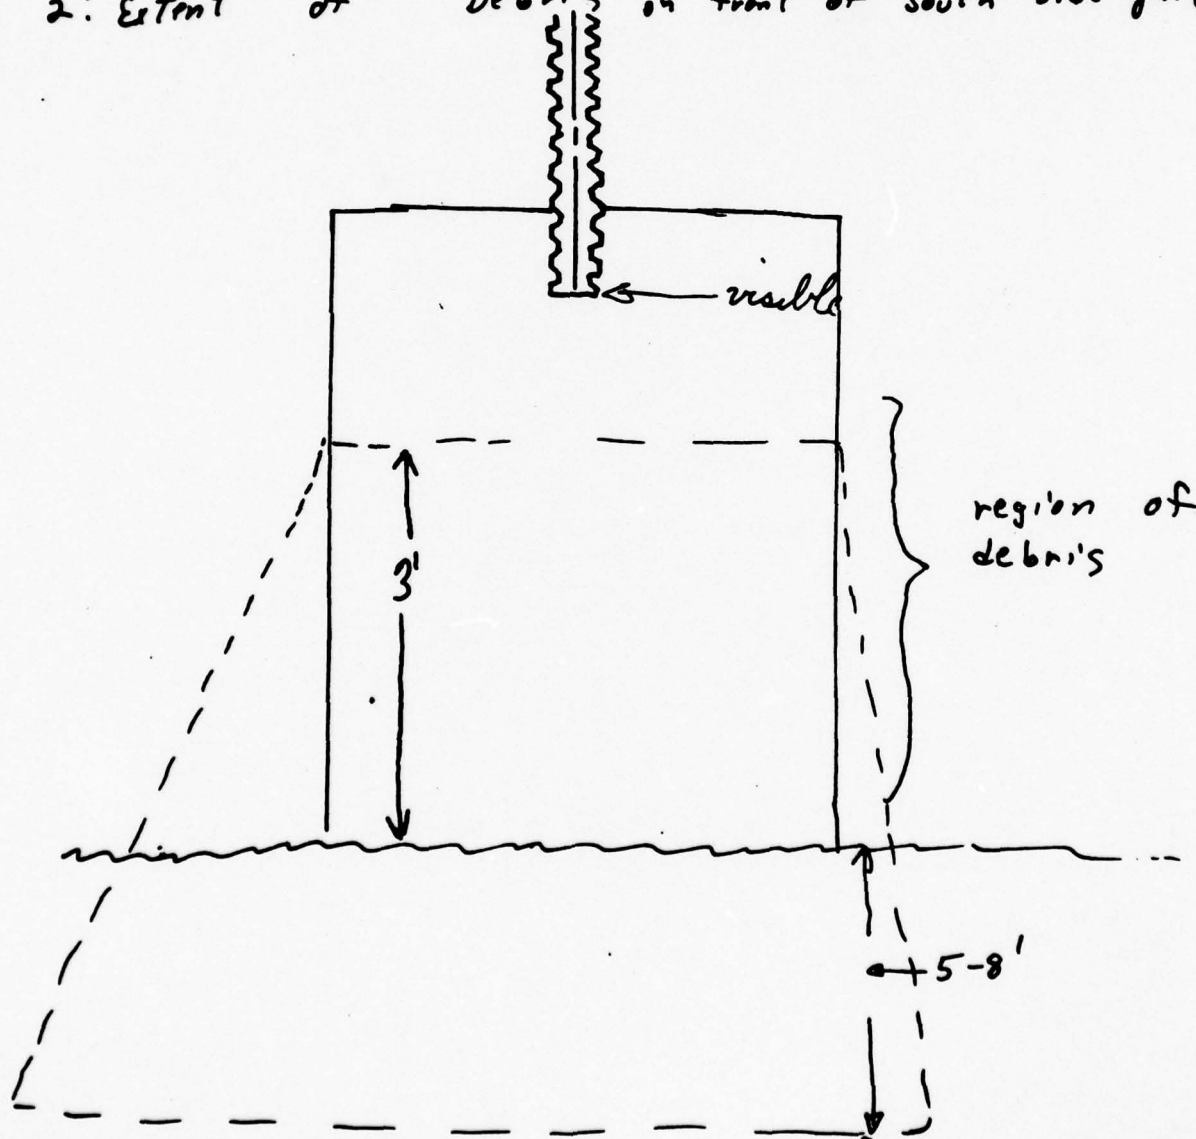
Fig. 2: Extent of Debris in front of South Side gate

DEBRIS: BROKEN TREE LIMBS, PULP WOOD, MISC HEAVY TRASH - GATE SEATS & TRACKS

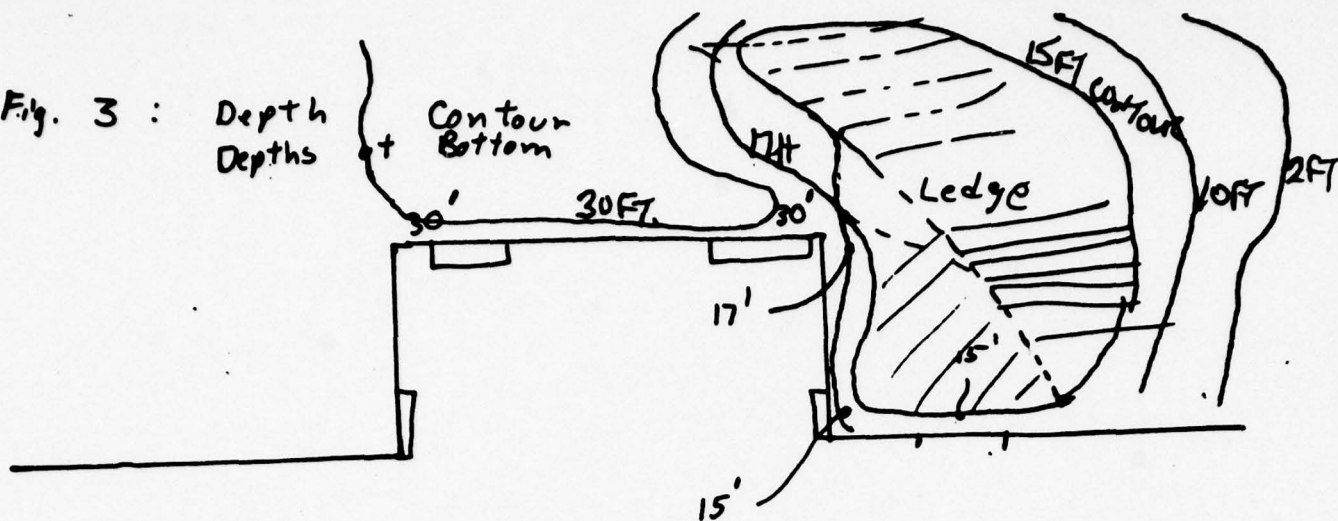
Fig. 3 : Depth  
Depths

Figure 3 shows bottom depths around the gate house structure. It also shows the steep ledge near the north gates. The ledge could act to funnel the flow of water and debris to the north gates. It is also possible that the south front gate is not operational, thus no flow and no debris. The south side gate is located at a dead flow zone. This would act to concentrate debris on the south side.

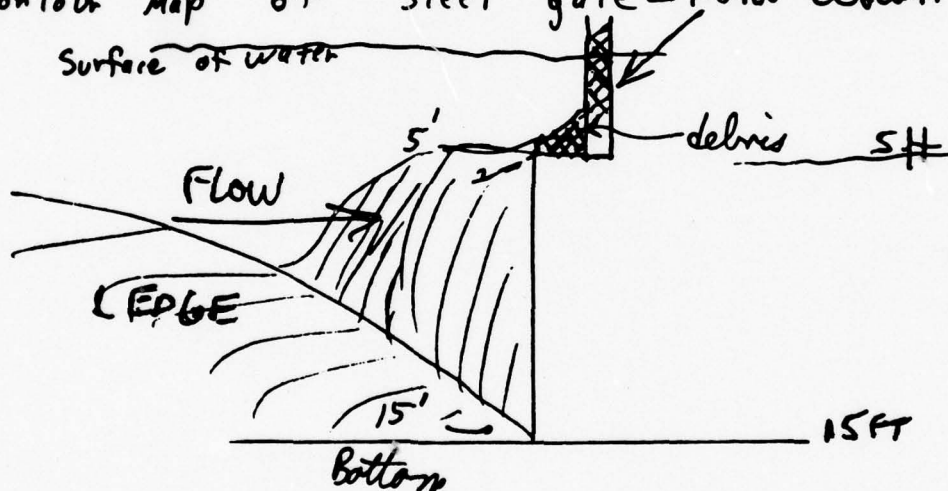
Fig. 4: Contour Map of Steel gate - MAN LOGWAY  
Surface of water

Figure 4 illustrates a profile of the steel door. The wood debris located at the obstructed gates was not evident at the base of the steel door. Salt and dirt filled in the lip as illustrated in figure 4.
